Millard Refrigerated Services Ammonia Release

By Christina Meyer

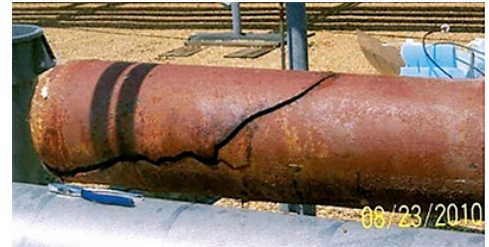
When using anhydrous ammonia, the hazard of hydraulic shock comes along with it. Hydraulic shock is the sudden, localized pressure surge in piping or equipment resulting from a rapid change in the velocity of a flowing liquid. The highest pressures often happen when vapor and liquid ammonia are present in a single line and are distributed by a sudden change in volume. This rapid change in pressure increase can result in the catastrophic failure of piping, valves, and other components.

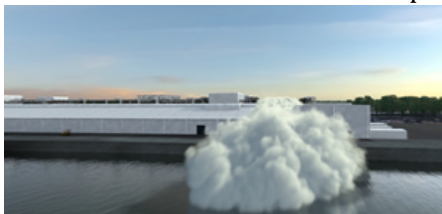
The facility lost power the day before which caused the refrigeration system to be shut down. When they regained power the next day, they brought the system live. Operators cleared the alarms while troubleshooting, which reset the refrigeration system. The control system got reset causing the freezer evaporator to switch directly from a step in the defrost cycle into refrigeration mode while the evaporator coil still contained hot, high-pressure gas. This reset triggered a valve to open causing low temperature liquid ammonia to be fed back into all four evaporator coils before removing the hot ammonia gas. This resulted in both hot, high-pressure gas and extremely low temperature liquid ammonia to be present in the coils and related piping at the same time. This caused the hot high-pressure ammonia gas to rapidly condense into a liquid. Liquid ammonia takes up less volume than ammonia gas, which created a vacuum where the gas had been. The void sent a wave of liquid ammonia through the piping. In the end hydraulic shock resulted. A roof-mounted 12-inch suction pipe catastrophically failed, which causes the release of more than 32,000 pounds of anhydrous ammonia. A Millard employee was injured due to falling while trying to exit the crane when the released ammonia cloud engulfed it. The large ammonia cloud traveled a quarter mile from the facility towards an area where 800 members reported symptomatic illnesses from ammonia exposure. Thirty-two of offsite workers ended up requiring

hospitalization, and four of them ended up in an intensive care unit. A key lesson taken away from this incident is avoid the manual interruption of evaporators in defrost and ensure control systems are equipped with password protection to ensure only trained and authorized personnel have the authority to override systems. Also design ammonia refrigeration systems where each evaporator coil

should be controlled by a separate set of valves rather than multiple coils connected to a valve group. The final lesson is that if there is a release of ammonia and a leak cannot be promptly isolated and controlled, an emergency shutdown should be activated in order to reduce the amount released.
